NFOWARNING

## H5+ (cod. C1208.02)

## Warning

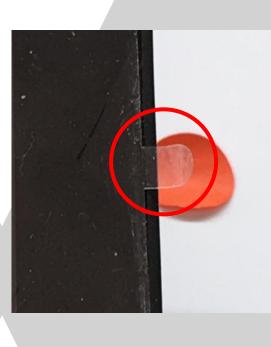
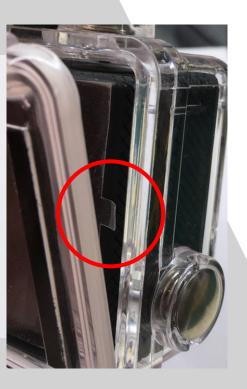
If the film is not removed, <u>water will infiltrate</u> in waterproof case. The side tab doesn't allow the perfect closing of the gasket.

We recommend always to remove the protective film on H5+ camera screen.

We recommend to advise your customer to peel off the protective film, especially if used with waterproof case.
